AVIATION BASE BUILDING  
KIRKUK, IRAQ

**SIGIR PA-06-040**  
**APRIL 12, 2006**

SUBJECT: Report on Project Assessment of the Aviation Base Building, Kirkuk, Iraq  
(Report Number SIGIR-PA-06-040)

## **Aviation Base Building, Kirkuk, Iraq**

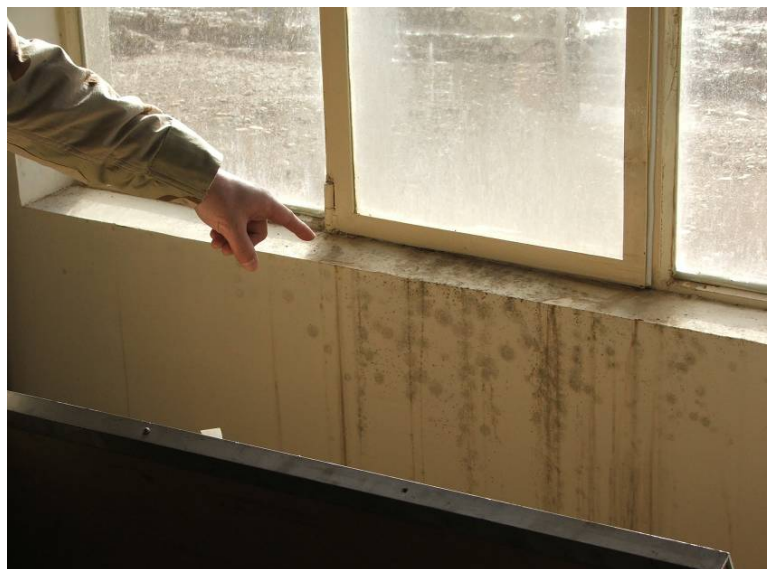
Two days prior to our site visit, the Kirkuk area experienced significant rainfall. During the site visit, we identified water damage within the hangar's offices (Site Photo 9) and bathroom. The cause of the water damage was twofold – the windows were not properly sealed and the outside window ledge was flat, resulting in insufficient drainage. Consequently, the water leaked around or through the window frame into the hangar office rooms and down the wall (Site Photo 9) and onto the floor (Site Photos 10 and 11). The contractor's project manager was on site during the assessment and stated the problem was being addressed. The contractor was in the process of drilling drain lines on the outside of the windows (Site Photo 12).

**Site Photo 9. SIGIR Engineer pointing out water leakage**

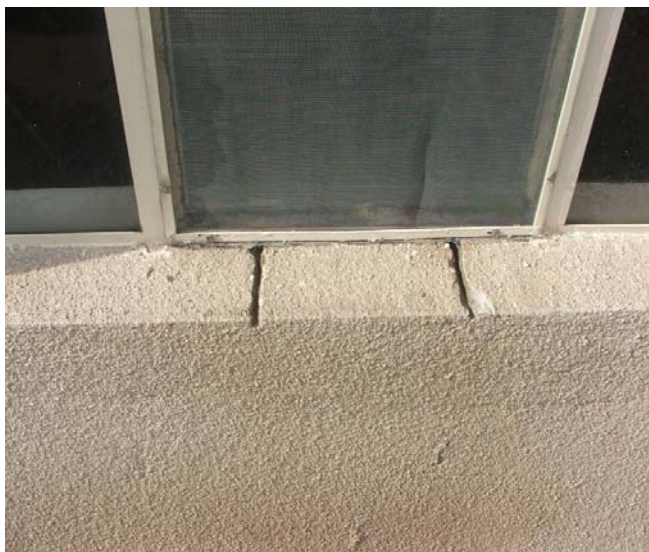
**Site Photo 12. Contractor's fix for window drainage (drain lines)**

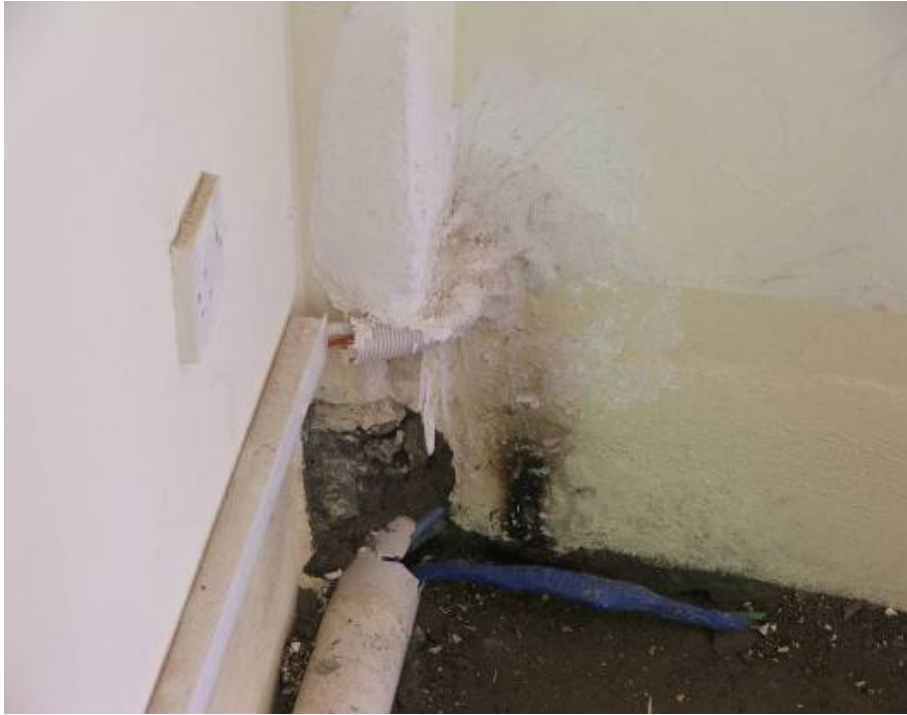
During the site assessment, USAF personnel pointed out an area of the aviation hangar which was scorched because of a fire due to an electrical short circuit. Site Photo 13 shows the burn from the fire and the partial repair to the wiring problem. Additional repairs will be required to ensure another short circuit will not occur in the future. Further, in mid-December 2005, upon moving into the aviation hangar, the USAF representative stated that he had to point out to the contractor that the wiring in one of the offices was not installed correctly and ultimately had to be re-done.

Site Photo 13. Small fire damage and repair to the wiring

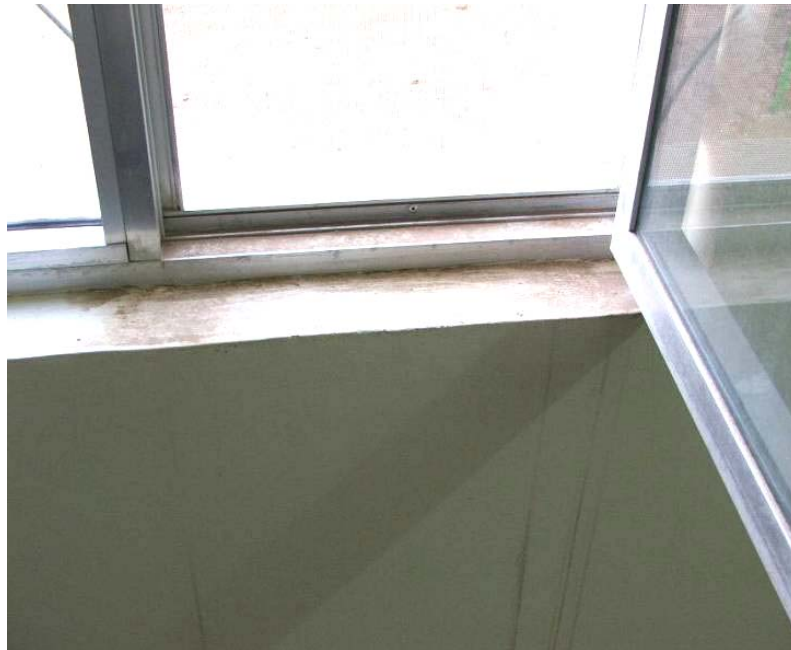
The first floor provided the Iraqi Air Force with living quarters. Currently, each room housed four Iraqi Air Force personnel with each person provided a bed, a metal locker, and lighting above the bed (Site Photo 18),. In addition, each room consisted of two windows a split air conditioning (A/C) unit, two ceiling fans (Site Photo 19), and fixed connections for all electrical equipment (Site Photo 20). We identified water leaking from windows in the living quarters (Site Photo 21) and office spaces, similar to the problems found in the aviation hangar.

**Site Photo 21. Close-up view of water leaking through window**

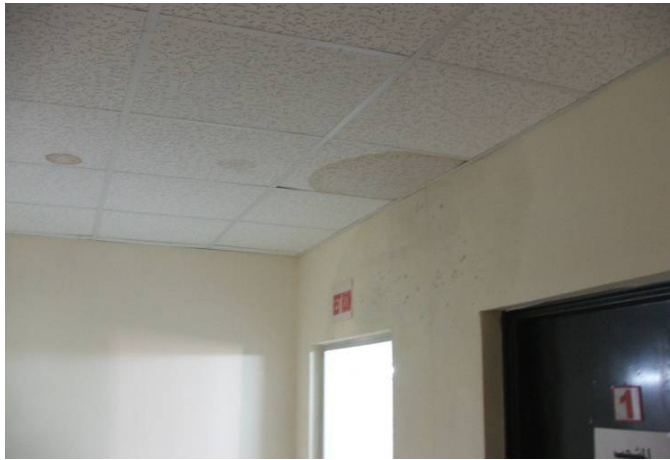
We identified plumbing issues on the ground and first floors. For example, water leaked from the first floor restroom through to the ground floor ceiling, damaging the ceiling tiles (Site Photos 27 and 28).

**Site Photo 28. Example of water leakage**

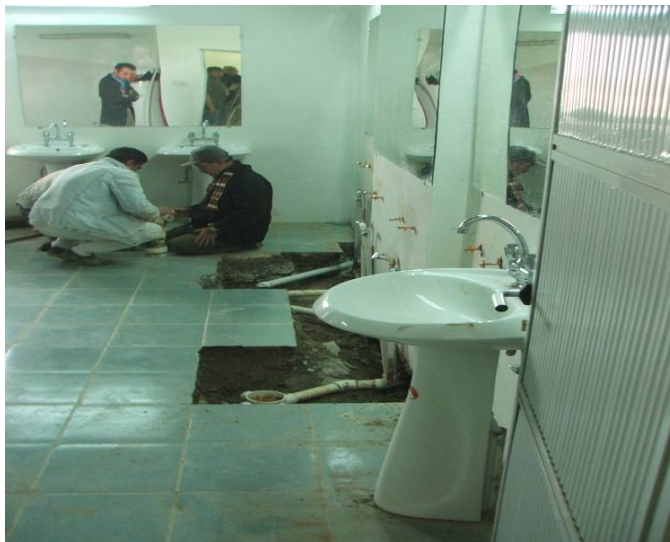
In addition, in the first floor restroom, the contractor removed floor tile in an effort to determine the cause of the leak (Site Photo 29).

**Site Photo 29. Floor tiles removed to determine cause of leak**

The contractor responded to the letter by making repairs under the contract’s warranty. We observed some corrective actions during the site visit. As mentioned in the site assessment section of the report (Site Photo 29), the contractor has removed the bathroom tiles to identify the cause of the leak and will correct the damage to the ground floor ceiling that was caused by the leak.

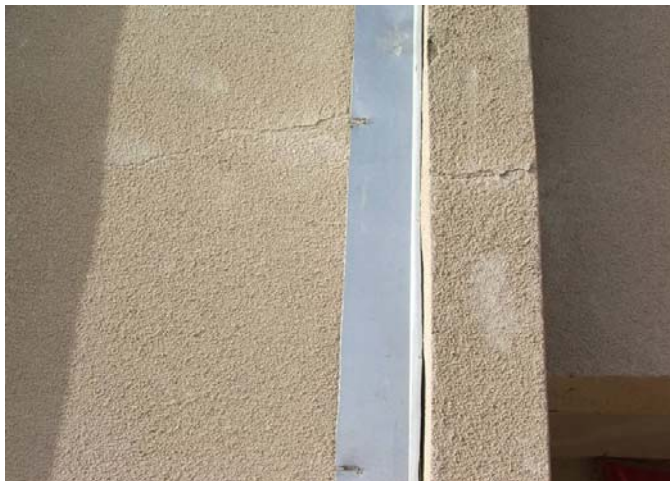
During the site assessment, we also identified minor construction issues that the contractor needs to correct under the contract's warranty. For instance, there were cracks in the outside wall stucco (Site Photo 30).

**Site Photo 30. Cracks in the outside wall stucco**
